Repair of Blast Furnace Hearth and Tuyere Using Shotcrete Technology

Dr. Saumen Sinha, Manir Uz Zaman, Aditya Soni and Santosh Upadhyay
Calderys India Refractories Limited, Nagpur

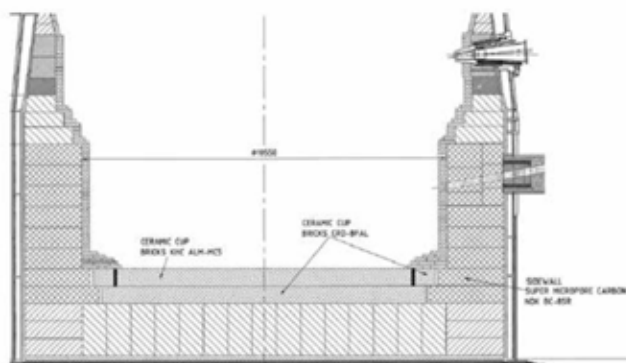
Figure 1: A typical hearth lining

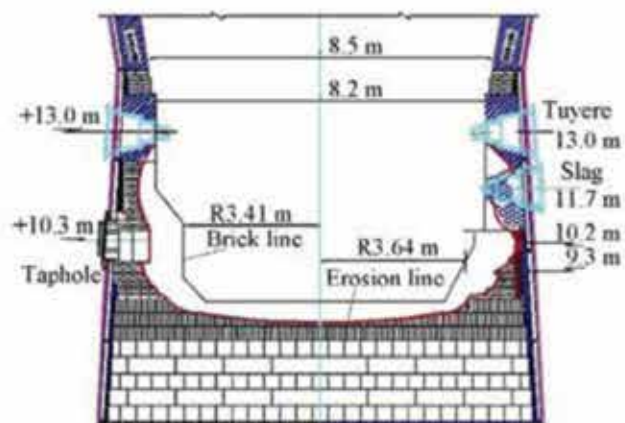
Figure 2: Erosion profile of a Blast Furnace Hearth

- Penetration of hot metal into the carbon bricks
- Erosion resulting from the dissolution caused by carburisation
- Erosion by hot metal owing to the peripheral flow
- Chemical attack from alkali, zinc oxides, molten slags and iron
- Attack by oxide gases, e.g., CO₂, H₂O

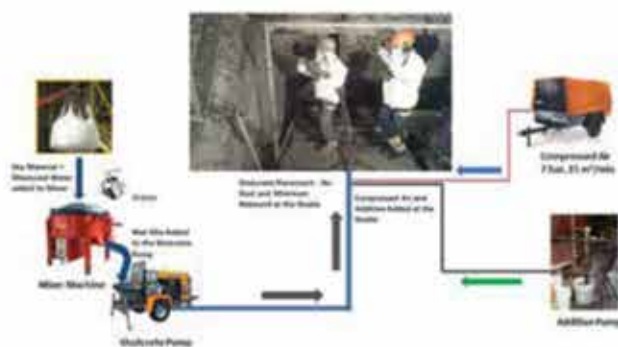
Figure 3: Shotcrete scheme

Shotcrete involves the pumping of mixed castable material to a nozzle where the admix and compressed air is added at a certain dose, which enables the sprayed material setting on the target surface.

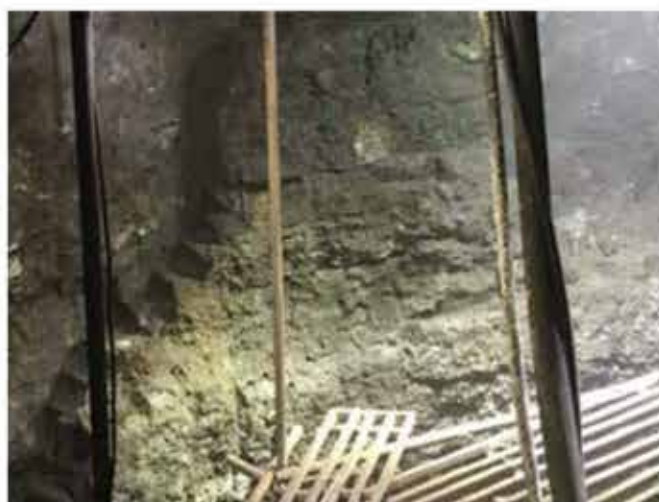
Figure 4: View of the old lining

The surface cleaning of the old lining is of utmost importance as it governs the adhesion of the newly installed lining with the old surface. In case of improper cleaning of the surface, the performance of the lining is doubtful.

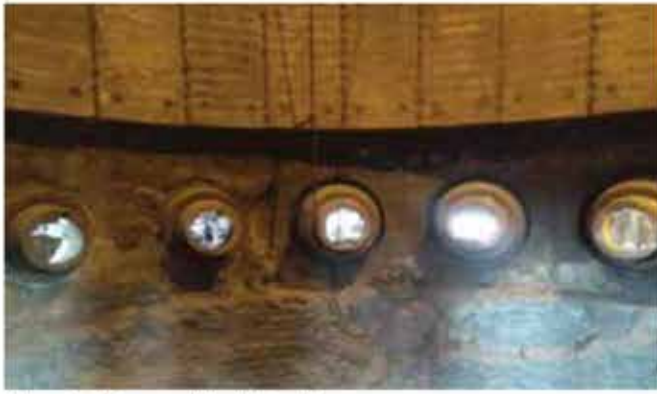
Figure 5: Lining condition before Shotcrete

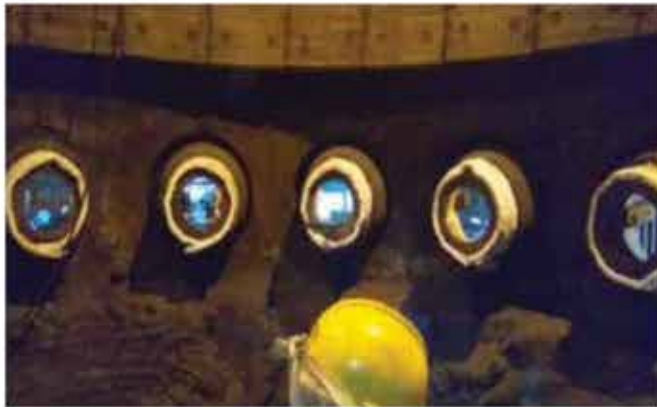
Figure 6: Preparation of the Shotcrete

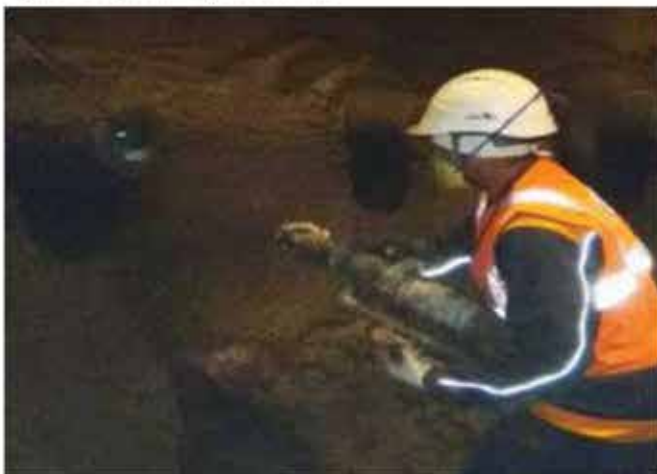
Figure 7: Installation of Shotcrete

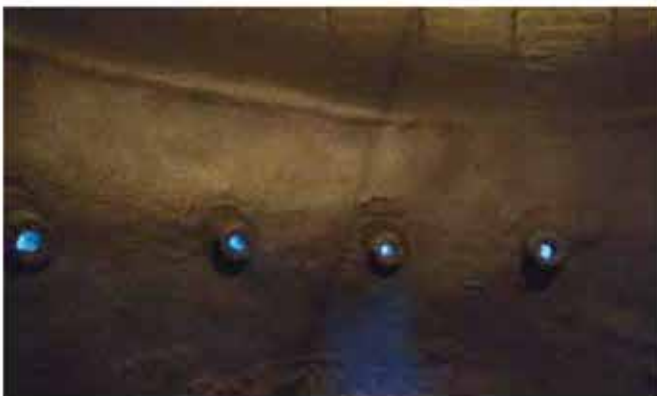
Figure 8: Lining condition after Shotcrete

were installed on hearth side wall up to tuyere (Figure 8) by means of Manual Shotcreting. Installed refractory lining thickness was in the range of 250 to 450 mm. The appearance of the installed Shotcrete mass is shown in Figure 9.

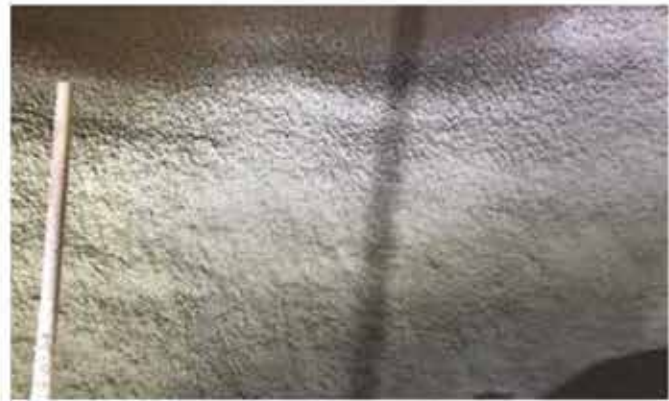
Figure 9: Lining condition after Shotcrete

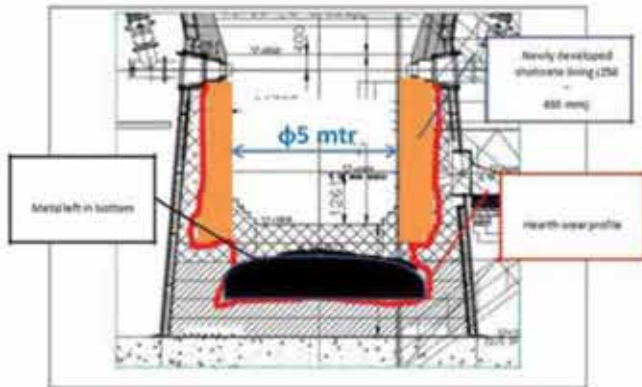
Figure 11: Schematic of the Shotcrete repair performed

Case 1: Calderys India Refractories was the pioneer to introduce BF hearth Shotcreting in MBF in India. ACCSHOT BFHS2 was used for hearth repair of one MBF, of capacity 350 m³. The furnace is 12 years old and produces approximately 1000 Tonnes of Hot Metals/day. Old lining (mullite bricks) was cleaned, as shown in Figure 7, before Shotcreting. The refractory surface is required to be exposed for better adherence of existing refractory with the repair mass. 80 Tonnes of ACCSHOT BFHS2

Dry out of the hearth Shotcreted lining was done before furnace blow in. The furnace was operational for 6 months approx. and then it was taken for capital repair in which carbon blocks replacements were planned. After the opening of the furnace, it was observed that the Shotcrete lining was still present in the furnace with minimum erosion.

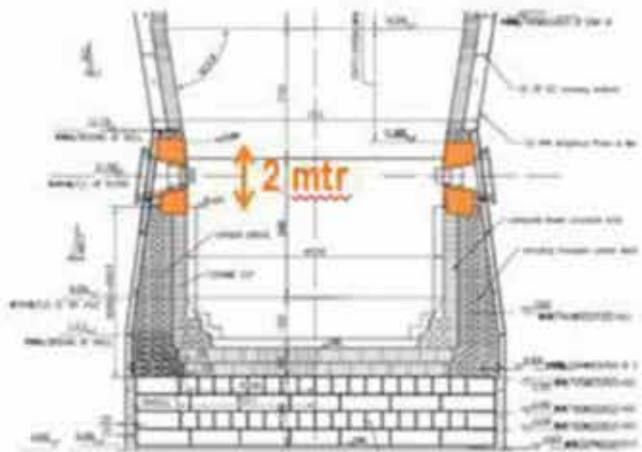
Figure 12: Schematic of the repair

Case 2: A second repair was carried out in a furnace of size 550 m³. The furnace was non-operational for a few years and was to be started in a very short time period. The lining in the vicinity of tuyere area (approx. 1 mtr below and above) was not in good condition and for the successful operation of the BF, the lining must be repaired.

The Shotcrete installation was done by Calderys with a quantity of 55 Tonnes of ACCSHOT BF HS2 in a timeframe of 6 Hrs.

The lining was heated to 550°C using pilot burners before taking the Blast Furnace into operation.

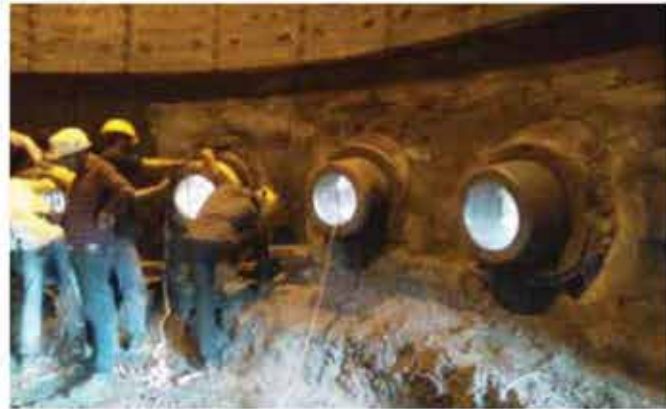
Figure 13: Lining before Shotcrete

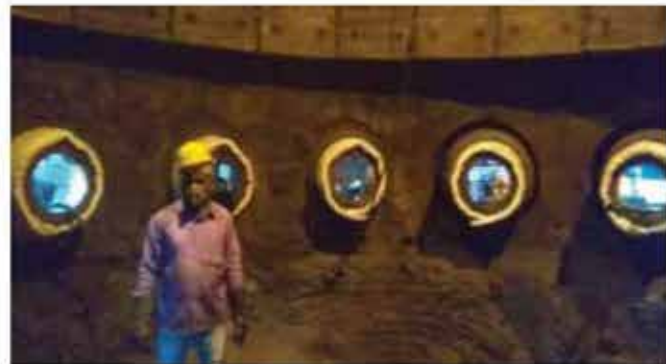
Figure 14: Preparation of the Shotcrete

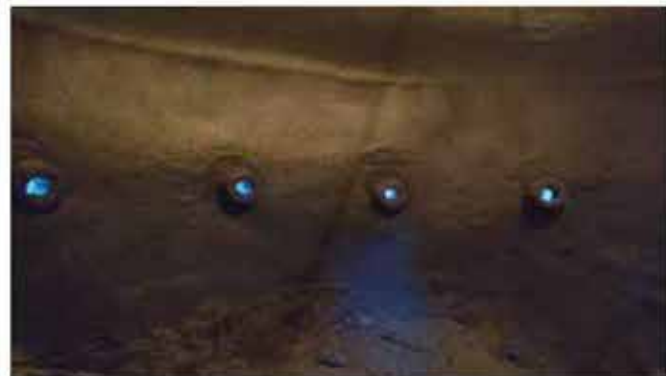
Figure 15: Preparation of the Shotcrete
